14 Garden Street
Katoomba NSW 2780

Inspection Date:

22/05/23

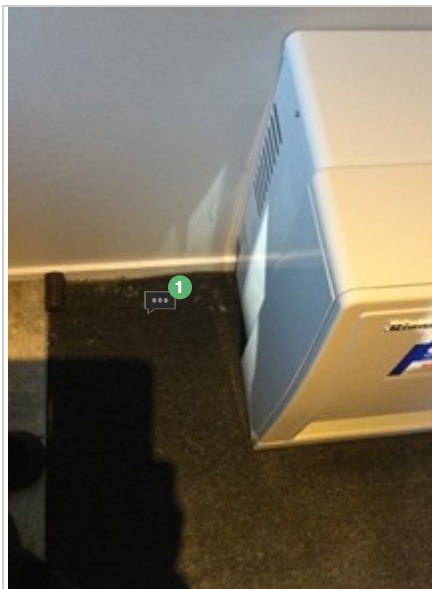
Image 2

1. white marks on carpet

1. Clean marks in laundry
2. Clean up white powder on floors

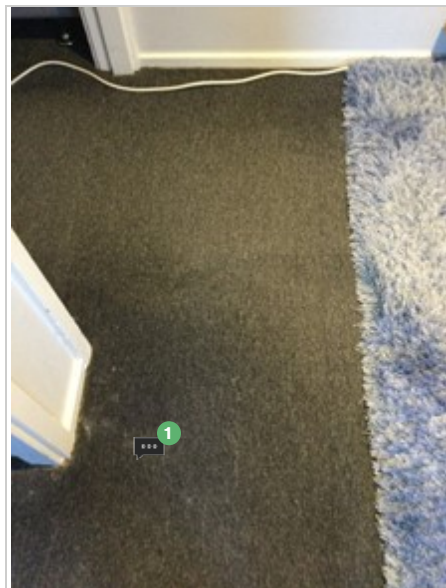
Image 3

1. white marks on carpet

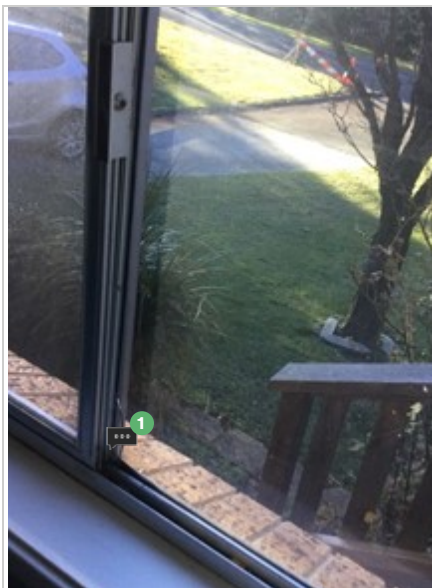
Image 4

1. crack in window

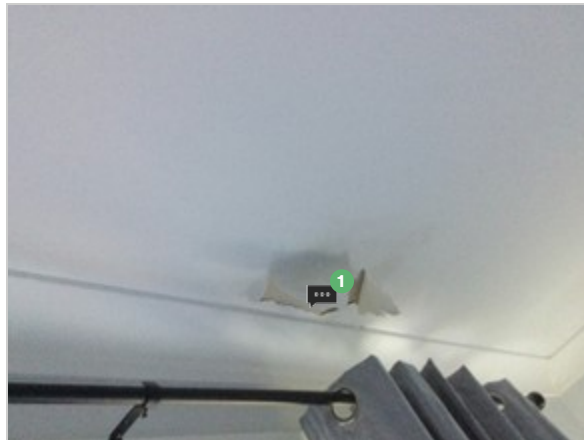
[Image 6](#)

1. paint peeling

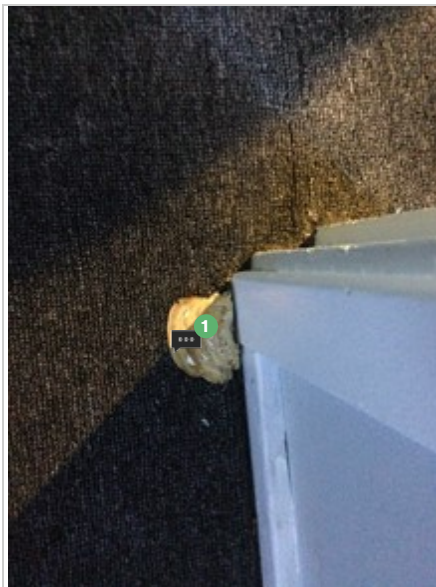
[Image 8](#)

1. on carpet

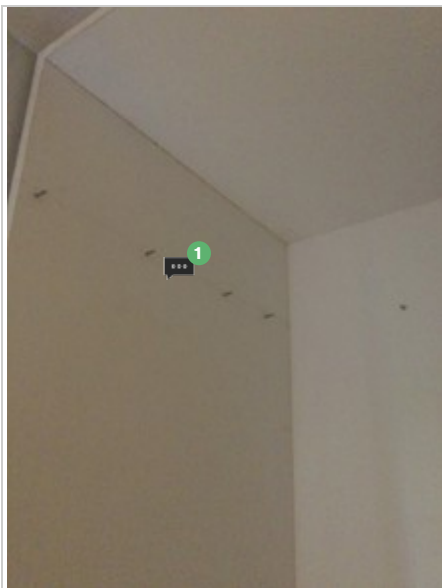
[Image 11](#)

- 1. screws coming through the cupboard

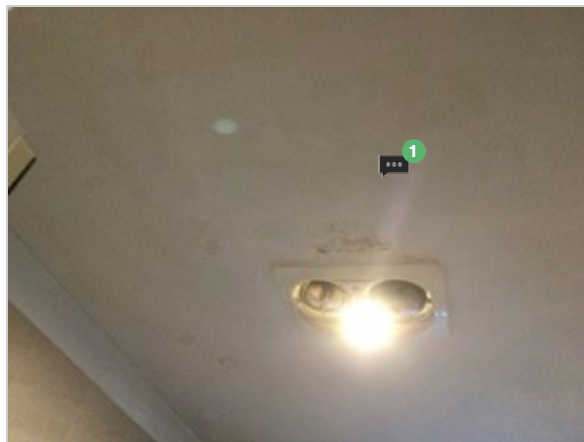
[Image 14](#)

- 1. paint peeling

1. Fix fence
2. Remove tree climbing equipment or repair
3. Fix leaking shower (urgent)
4. Scrape back peeling paint and repaint
5. Paint weathered barge boards and pressure wash deck and re-oil to protect from rotting.

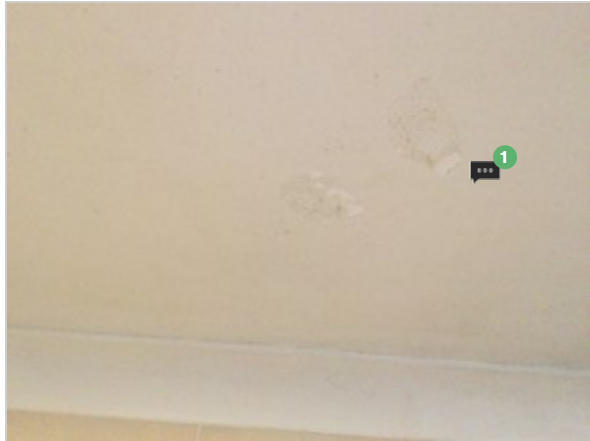
[Image 17](#)

- 1. paint peeling

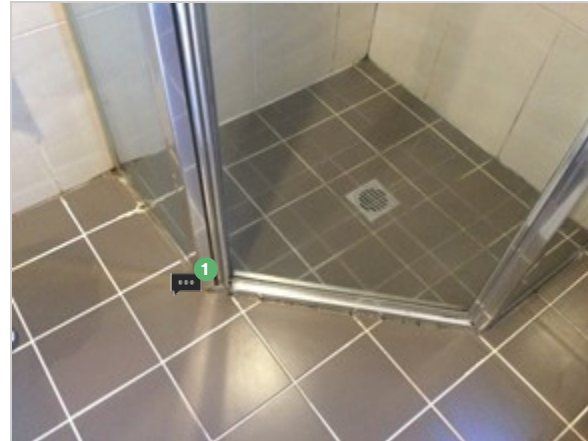
[Image 18](#)

Bathroom	Y	N	Y	<p>Clean and tidy at the time of inspection. I noticed the ceiling had many peeling paint spots. The tenant also reported that the shower sometimes leak out the side of door (image 18) The tiles and grout are in a great condition.</p> <p>Refer to media: 14 15 16 17 18 19 20</p>
Kitchen	Y	N	N	<p>The tenant reports she never used the dishwasher or oven. I noticed some of the cupboard doors laminate was chipping (image 25) The cornice above the cupboards has not been painted and there are marks on the wall behind the fridge area. The tiles are in a good condition with no cracks.</p> <p>Refer to media: 21 22 23 24 25</p>
Dining Room	Y	N	N	<p>Used just to store boxes. There is paint peeling on the ceiling. (image 27)</p> <p>Refer to media: 26 27</p>
Laundry	Y	Y	N	<p>Tenant claims she only used this area for storages. I noticed a few marks on the ceiling I've asked the tenants to try to clean these off and a section of wall that has not been painted. (image 31)</p> <p>Refer to media: 28 29 30 31</p>

- 1. Water leaks out of shower screen

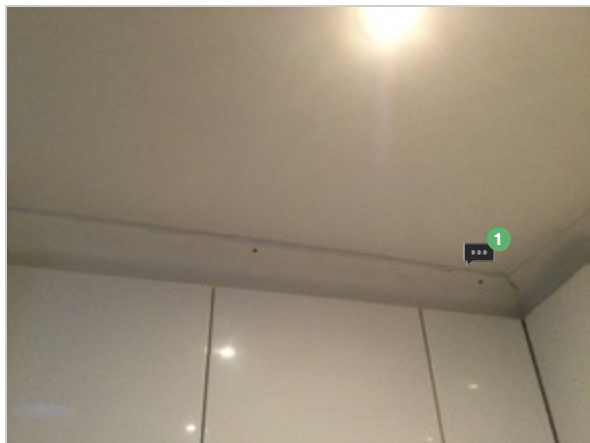
[Image 23](#)

1. not painted

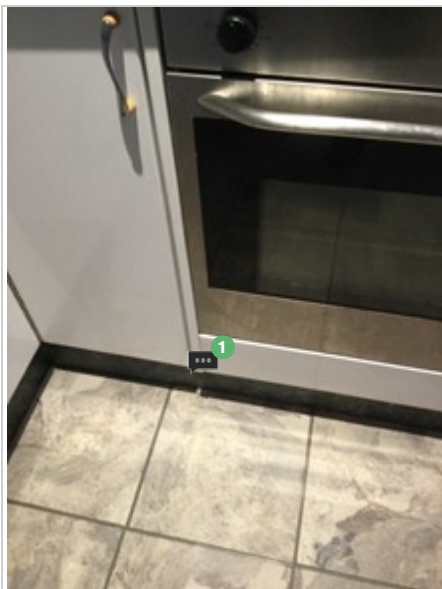
[Image 25](#)

1. paint chip

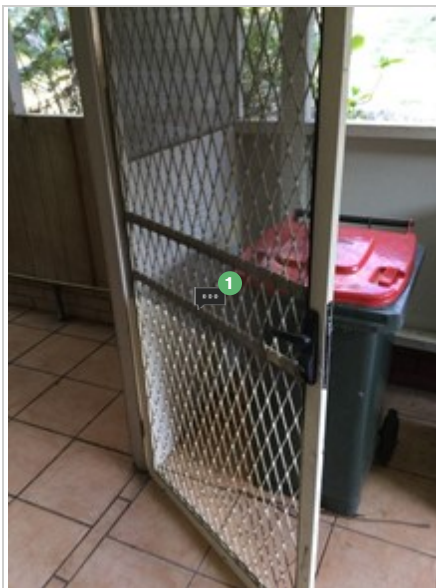
Image 32

Outdoor Room	Y	N	N	<p>A few cobwebs and dust. Tenant never uses this area. She says the door is fiddly and sometimes bangs in the wind if not closed and the the handle jiggled. I noticed a few tiles have cracks in them.</p> <p>Refer to media: 32 33 34 35 36</p>

1. rattles

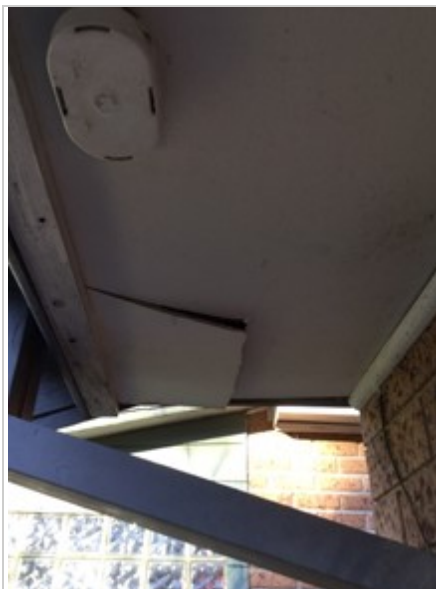
Image 38

The deck and stairs look dry and weathered. I noticed a piece of eave having down (image 38)
The barge boards on the roof have paint chipping and looking weathered. Could use a paint in the future to protect the wood from rotting. The side fence is on a slant and has broken panels and beams (images 43-46) The climbing platform looks weathered and old and not very stable. Might be worth removing so if the tenant has any children visitors they are going to get hurt.

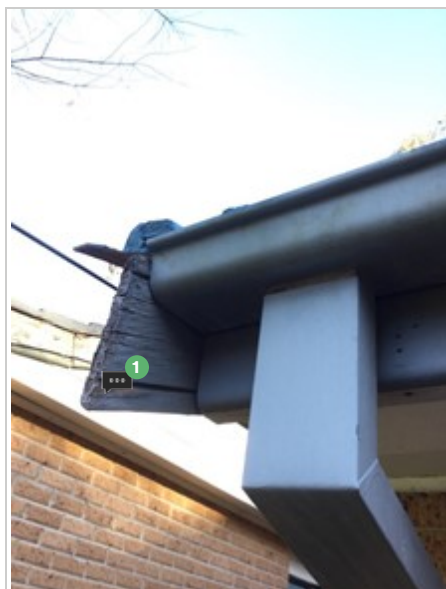
Image 39

- 1. barge board broken

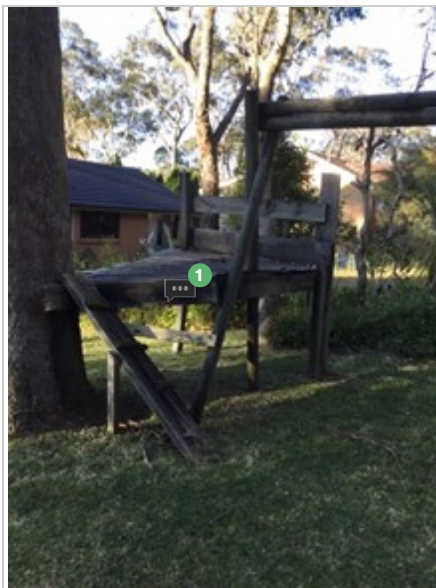
Image 48

1. not stable

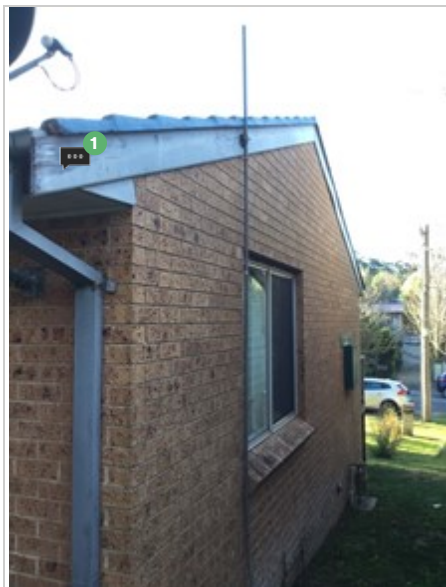
Image 51

- 1. weathered barge board

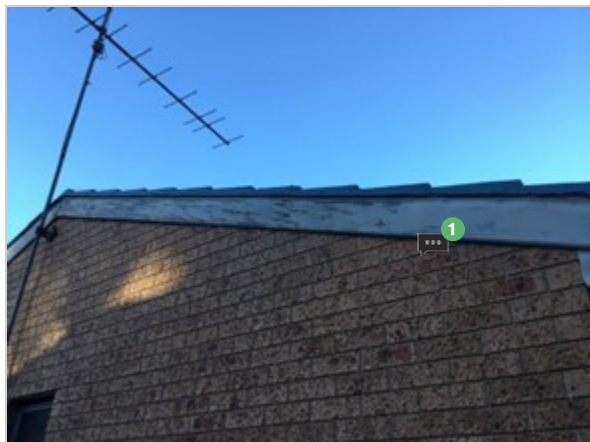
Image 53

- 1. weathered barge board
