14 Garden Street
Katoomba NSW 2780

Inspection Date:

22/05/23

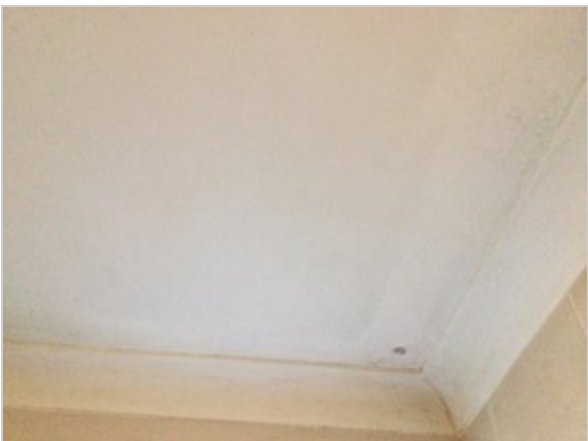
[Image 15](#)

Bathroom	Y	N	Y	<p>Clean and tidy at the time of inspection. I noticed the ceiling had many peeling paint spots. The tenant also reported that the shower sometimes leak out the side of door (image 18) The tiles and grout are in a great condition.</p> <p>Refer to media: 14 15 16 17 18 19 20</p>
Kitchen	Y	N	N	<p>The tenant reports she never used the dishwasher or oven. I noticed some of the cupboard doors laminate was chipping (image 25) The cornice above the cupboards has not been painted and there are marks on the wall behind the fridge area. The tiles are in a good condition with no cracks.</p> <p>Refer to media: 21 22 23 24 25</p>
Dining Room	Y	N	N	<p>Used just to store boxes. There is paint peeling on the ceiling. (image 27)</p> <p>Refer to media: 26 27</p>
Laundry	Y	Y	N	<p>Tenant claims she only used this area for storages. I noticed a few marks on the ceiling I've asked the tenants to try to clean these off and a section of wall that has not been painted. (image 31)</p> <p>Refer to media: 28 29 30 31</p>

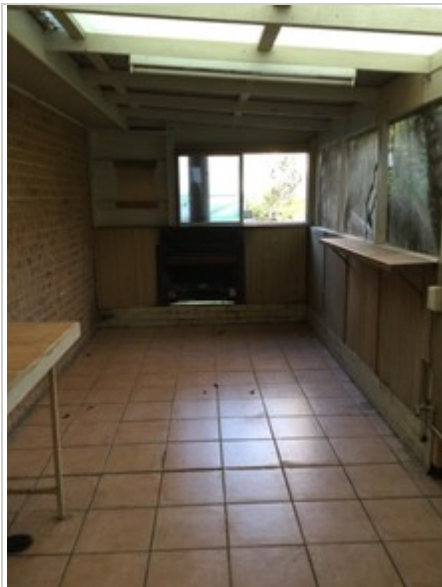
Image 33

Outdoor Room	Y	N	N	<p>A few cobwebs and dust. Tenant never uses this area. She says the door is fiddly and sometimes bangs in the wind if not closed and the the handle jiggled. I noticed a few tiles have cracks in them.</p> <p>Refer to media: 32 33 34 35 36</p>

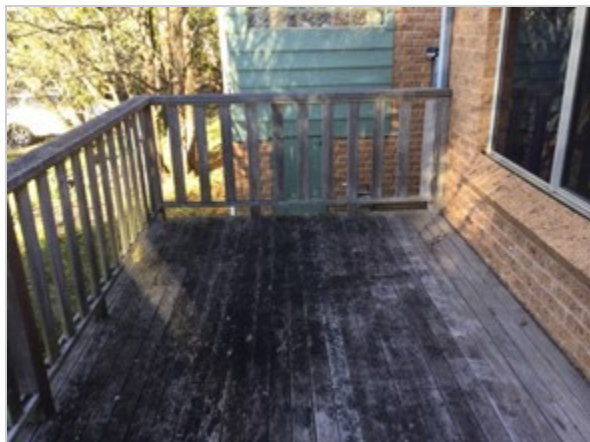
Image 37

The deck and stairs look dry and weathered. I noticed a piece of eave having down (image 38)
The barge boards on the roof have paint chipping and looking weathered. Could use a paint in the future to protect the wood from rotting. The side fence is on a slant and has broken panels and beams (images 43-46) The climbing platform looks weathered and old and not very stable. Might be worth removing so if the tenant has any children visitors they are going to get hurt.
